The Value of Lifeline Seismic Risk Mitigation in Christchurch

June 2012

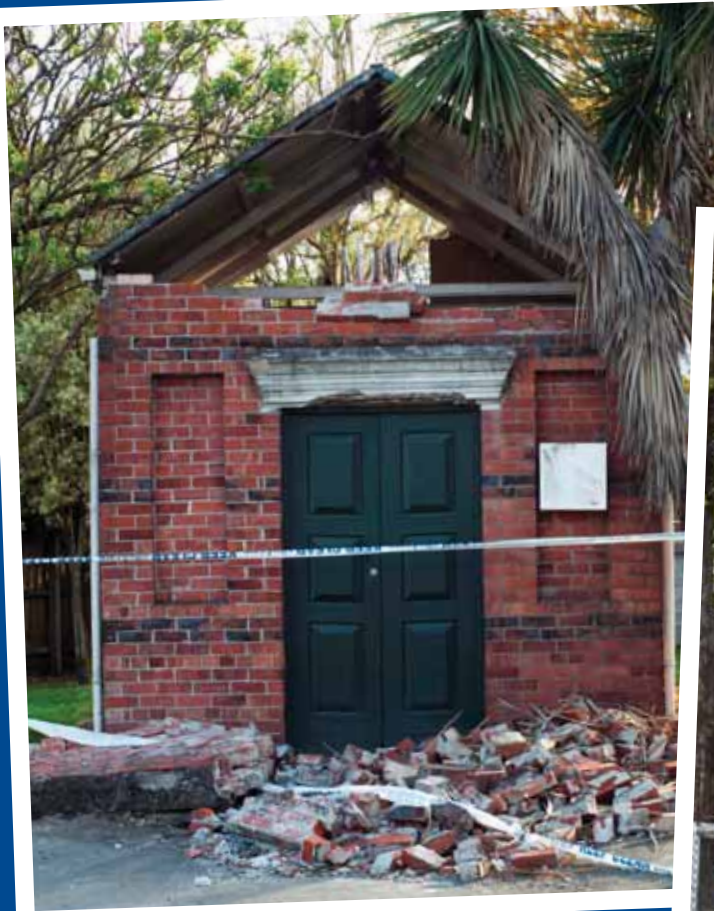
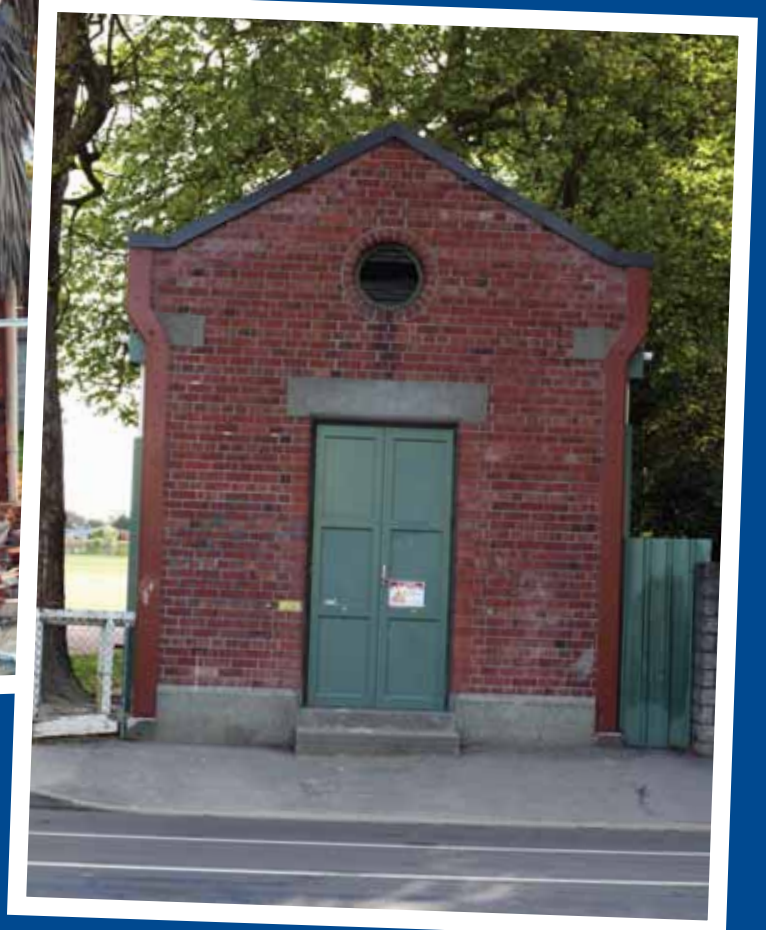
Cover Photos:

^ This electricity substation had been decommissioned prior to the earthquakes and was unstrengthened

Nearby strengthened electricity substation >

The photos illustrate the value of seismic mitigation, in this case, strengthening unreinforced masonry structures, many of which serve as substations in Christchurch's electricity network. The substation on the left had been decommissioned prior to the earthquakes and was therefore excluded from Orion's mitigation programme (it is no longer owned by Orion). The building was severely damaged in the September 2010 earthquake. The substation on the right, approximately 500 metres away, had been seismically strengthened and was largely undamaged. Strengthening work of this nature greatly assisted electricity restoration in Christchurch following the earthquakes. (Photo source: Orion New Zealand Ltd.)

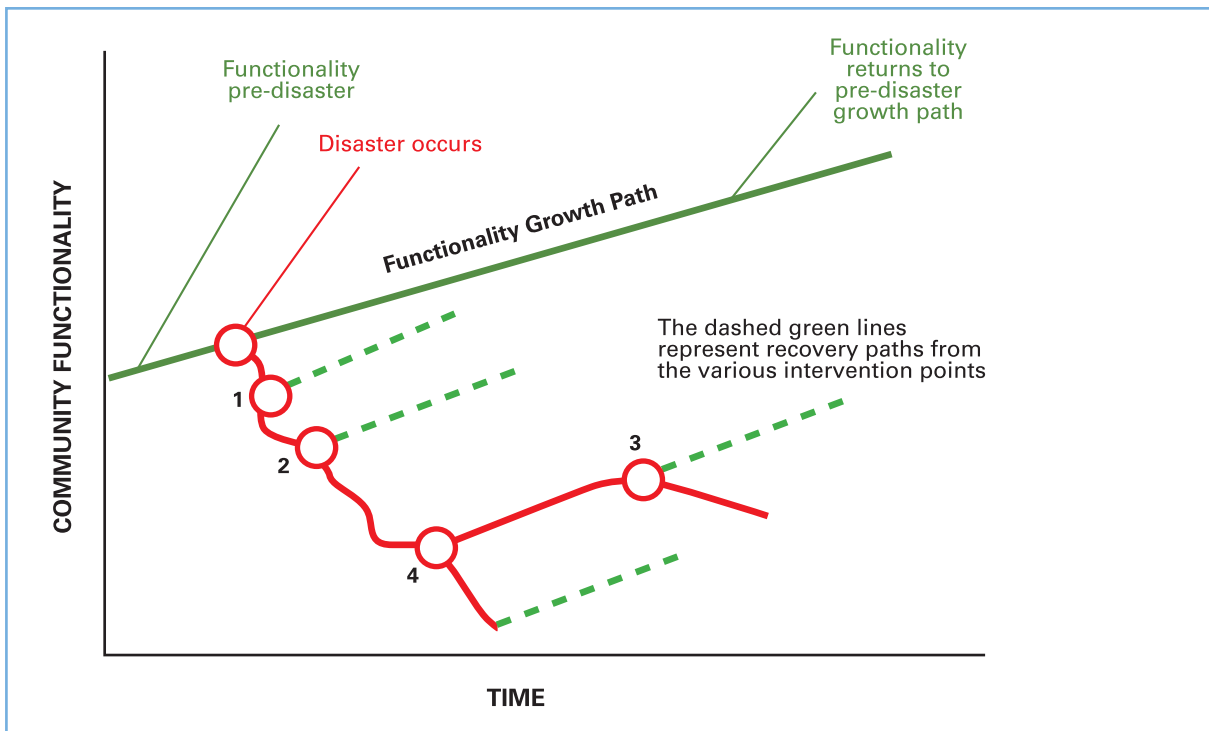
Figure 3: Intervention Points at which Community Loss May be Reduced

Notes: The size of the loss to the community is most effectively reduced by risk reduction action to prevent infrastructure outage (the loss may be stemmed early, at Point 1). Assuming ineffective risk reduction, actions to reduce the risk that infrastructure outages may spread to interdependent systems are depicted as a second line of defence (Point 2). Following commencement of a recovery, Point 3 illustrates gains from avoiding 'second-wave' outages (for example, subsequent outages in systems weakened by the earthquake, for example when aftershocks occur). Point 4 illustrates that major losses can occur if mitigation (risk reduction and readiness) are ineffective.
